Update "With-Site-Visit" Reserve Study

Rimrock Cove O.A. Coulee City, WA

Report #: 26309-1
For Period Beginning: January 1, 2020
Expires: December 31, 2020

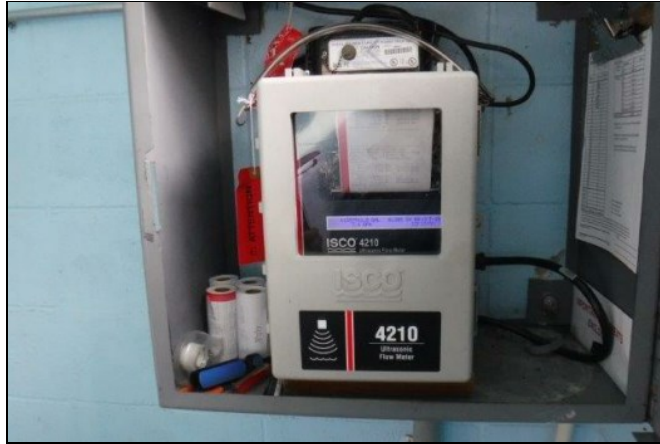
Comp #: 945 Sewer Flow Meters - Replace

Quantity: ~ (2) ISCO 4210

Useful Life:
10 years

Remaining Life:
3 years
