## “Full” Reserve Study

## Rimrock Cove Coulee City, WA

**Report #: 26309-0**  
**For Period Beginning: January 1, 2015**  
**Expires: December 31, 2015**  
**Date Prepared: November 14, 2014**

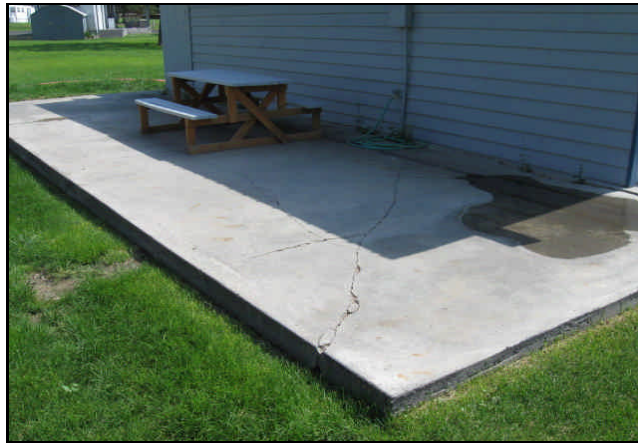
Comp # : 100      Concrete - Repair/Replace      Quantity : Moderate Sq Ft

Evaluation : Slab at upper bathroom has settled several inches creating large (>1") longitudinal crack, full separation from main slab. Damaged portion ~400 square feet.
