Update "With-Site-Visit" Reserve Study

Rimrock Cove O.A. Coulee City, WA

Report #: 26309-1
For Period Beginning: January 1, 2020
Expires: December 31, 2020

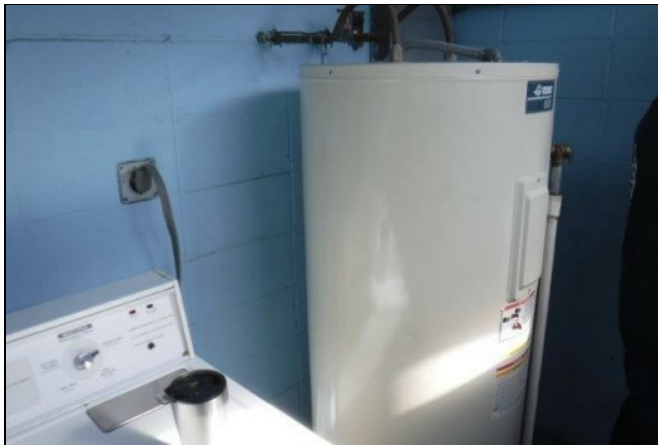
Comp #: 775 Water Heaters - Replace

Comments: No reported problems or signs of leaks, corrosion, etc. Best to plan for replacement as needed within the operating / maintenance budget, not as cyclical capital reserve projects.

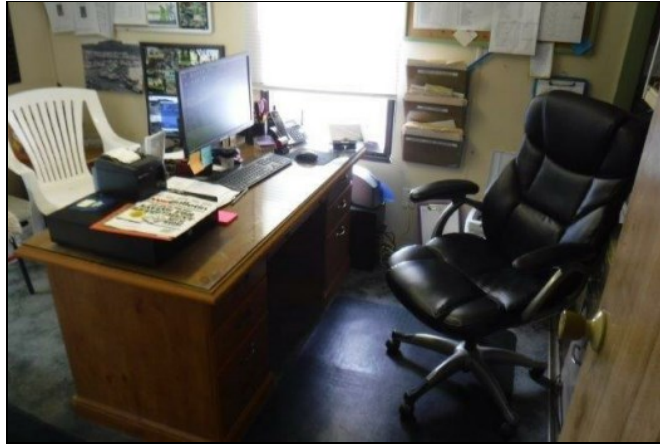
Comp #: 780 Office Furn & Equip - Replace

Comments: Office furniture and equipment appeared to be in functional condition with no problems reported.

Anticipate periodic replacement will be funded as general operating/maintenance expense as individually these are typically smaller in cost. No reserve funding suggested

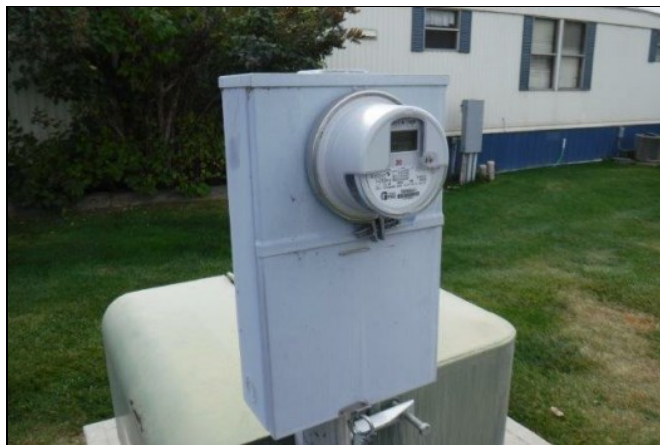
Comp #: 905 Electrical System - Repair/Replace

History: Phased (III) replacement ~ 2004 - 2006 (~\$710k)

Comments: It was reported in prior studies that distribution system was replaced in the mid 2000's due to failures of the original direct burial cable, and the community's need for increased service capacity, among other issues. The project was overseen by a professional engineer and there are currently no significant problems reported, or predictable expectation for large scale cyclical repair / replacement expenses within the 30-year scope of our report, therefore no reserve funding included.

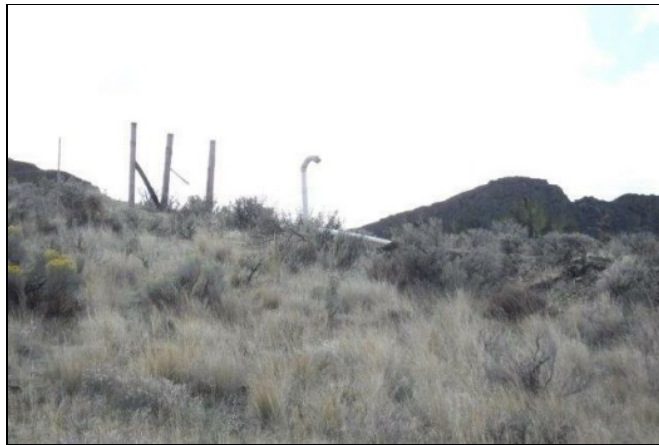
Comp #: 931 Water System Storage - Replace

Comments: Our source reported that water tank is a below ground tank. Low water pressure reported at upper homes, and our source indicated that tank may require replacement sooner than anticipated by our prior study.

Tank is reportedly a steel tank, which typically has a useful life of approximately 60 years. We have set remaining useful life to 5 years due to concerns reported by client. We recommend researching this project well in advance to determine scope, costs and timeframe for replacement.

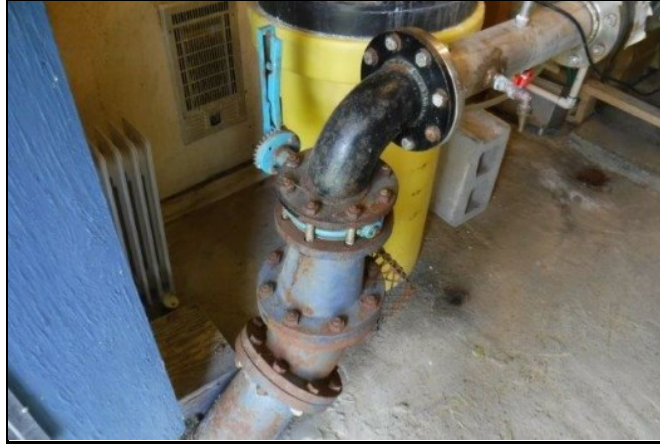
Comp #: 935 Well Pump - Replace

History: Replacement records 1978, 1990, 2016 \$10,725.12

Comments: Our source reported submersible well pump was replaced in 2016 at a cost of \$10,725.12.

Typically, replacement of pumps is more cost effective than refurbishing due to cost of pulling pump. Plan for a total useful life of approximately 15-20 years.

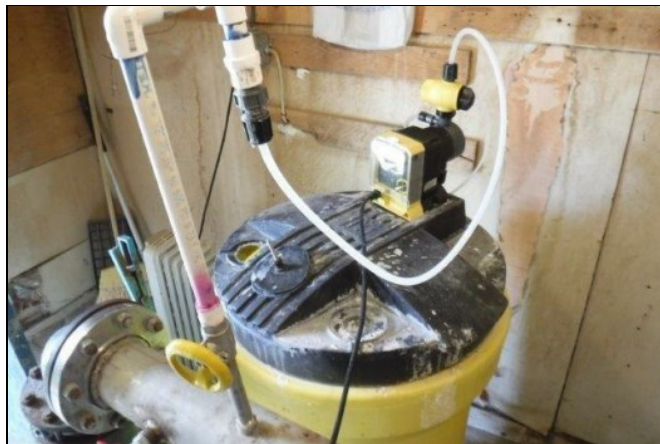
Comp #: 938 Chlorination System - Replace

Our experience has shown that the average useful life of chlorine pump is approximately 5 years, however cost is projected to be too low to qualify for reserve funding. As a result, treat replacement as general maintenance operating expense.

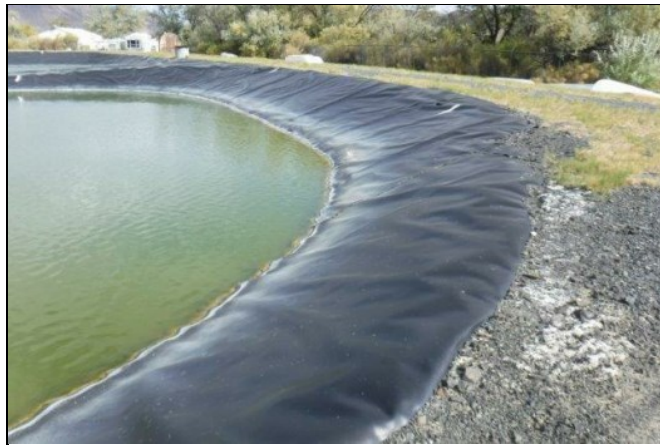
Comp #: 940 Sewage Lagoon Liners - Replace

Geoelectric leach location can detect any holes in liner. Liner service life can vary widely, depending upon a number of factors. We have used 30 years as a beginning point - we highly recommend you contact Dept. Of Ecology for assistance with geoelectric testing to assess the current condition of the liner, then incorporate any change in estimated remaining life into reserve study update.

Have professionally evaluated on regular basis. Maintain area surrounding, including fence (wildlife can cause great damage), and take care when removing any sludge not to damage liner.
