## “Full” Reserve Study

## Rimrock Cove Coulee City, WA

**Report #: 26309-0**  
**For Period Beginning: January 1, 2015**  
**Expires: December 31, 2015**  
**Date Prepared: November 14, 2014**

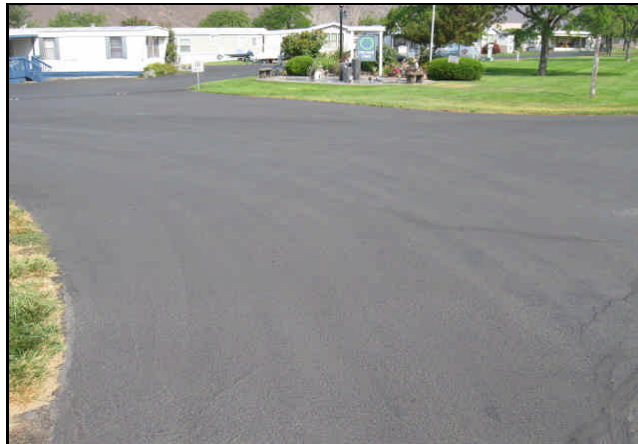
Pavement Surface Condition Field Rating Manual for Asphalt Pavement.

Useful Life  
30 years

Remaining Life  
21 years

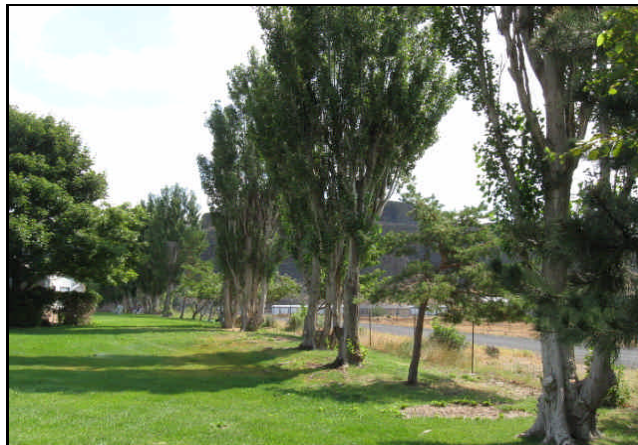
Remaining Life  
0 years

Best Case: \$12,100  
\$125/ea, Lower allowance to remove & grind stump,  
+ \$125/ea to replace ~ 1/3 of 145 trees

Worst Case \$16,900  
\$175/ea, Higher allowance to remove & grind  
stump, plus \$175/ to replace ~ 1/3 of 145 trees

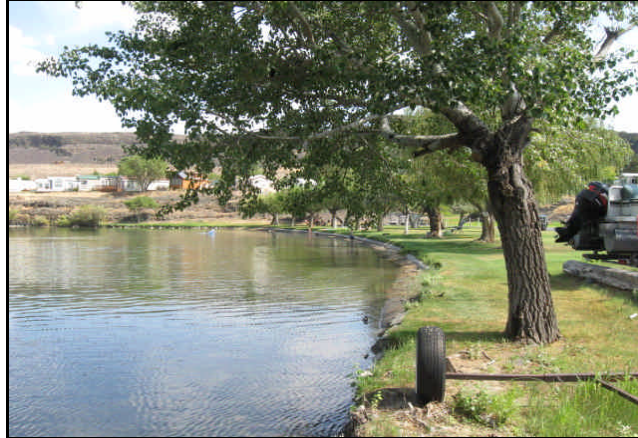
Useful Life  
3 years

Remaining Life  
3 years

Best Case: \$6,000  
Lower allowance to trim

Worst Case \$8,000  
Higher allowance

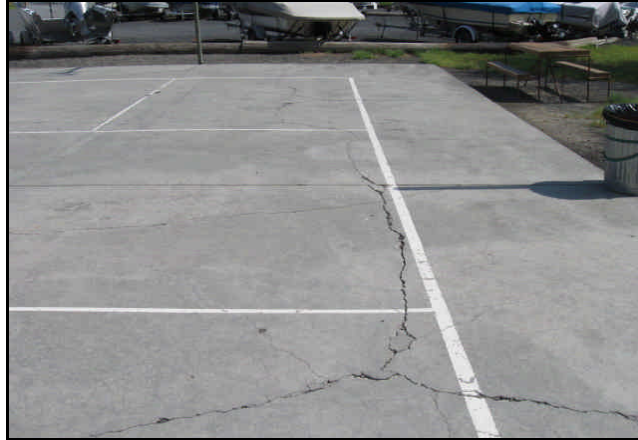
Useful Life  
20 years

Remaining Life  
0 years

Best Case: \$3,000  
Lower repair allowance

Worst Case \$5,000  
Higher allowance

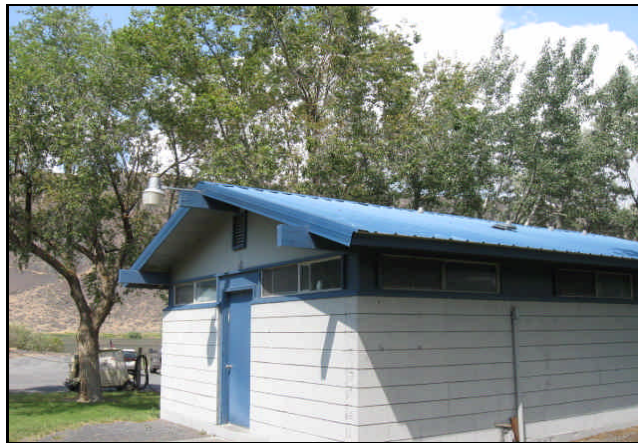
Useful Life  
40 years

Remaining Life  
20 years

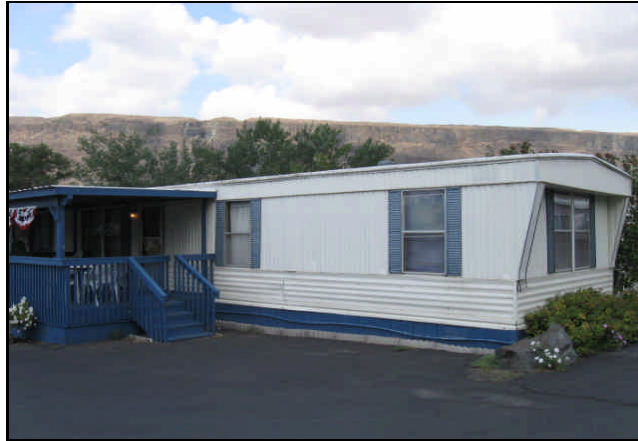
Useful Life  
50 years

Remaining Life  
10 years

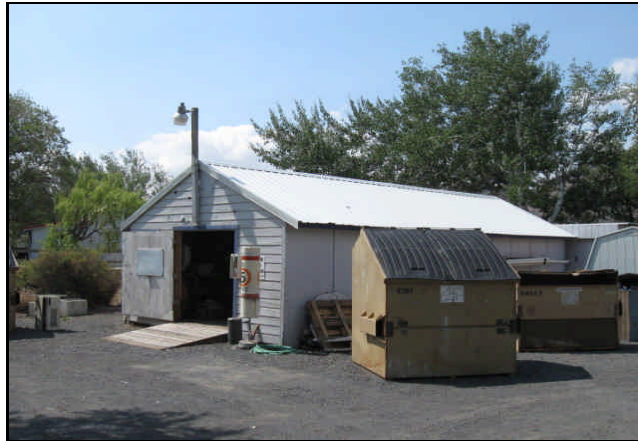
**Comp # : 600      Maint. Building - Repair/Replace      Quantity: ~ 1,100 GSF**  
Location : SW quadrant of property  
Funded? : Yes

Evaluation : The maintenance building does not rest upon a foundation, appears out of plumb, and areas of repair needs / deterioration were observed. This is a utility area, but is essential function to house and protect maintenance equipment and tools. Our recommendation would be to eventually replace with a heated metal storage building on concrete slab.

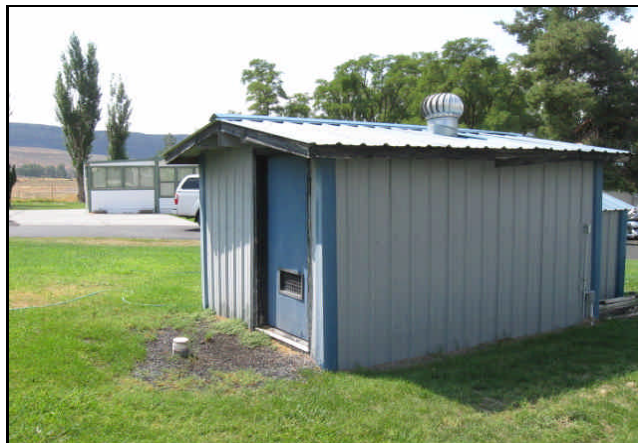
**Comp # : 605      Sheds, Well House - Repair/Replace      Quantity: (3) small structures**  
Location : Scattered common areas  
Funded? : No Annual costs, best handled in operational budget

Evaluation : Varying condition. The well house has advanced deterioration of fascia, trim and rafter tails - repairs needed soon. Shed at sewer lagoon appears a bit weathered, but stable. Shed near maintenance shop is newer. It is our expectation that local repair / replacement of these small structures will be funded through annual operating / maintenance budget based upon need that year. No reserve funding for large scale repair / replace suggested at this time.

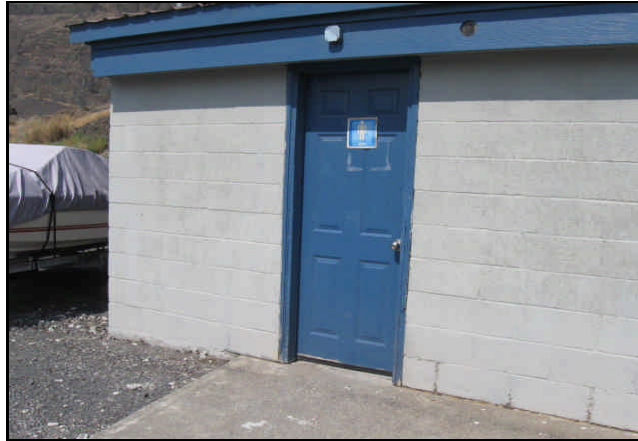
Evaluation : Painted surfaces were noted to be in generally fair condition. Regular cycles of painting are recommended to maintain appearance and protect surfaces, but we assume this is handled through operating / maintenance budget. No reserve funding suggested at this time.

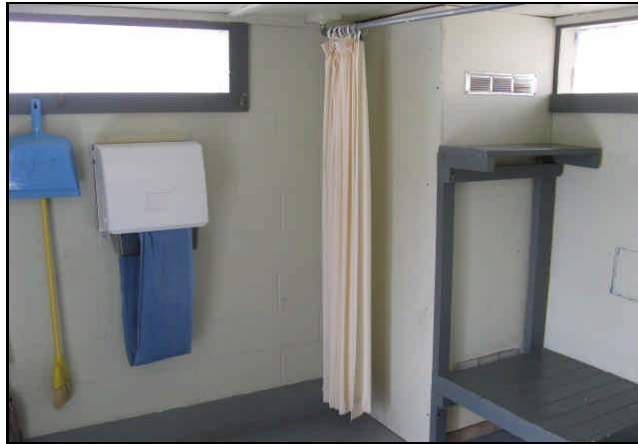
Evaluation : Painted surfaces were noted to be in generally fair condition. Regular cycles of painting are recommended to maintain appearance and protect surfaces, but we assume this is handled through operating / maintenance budget. No reserve funding suggested at this time.

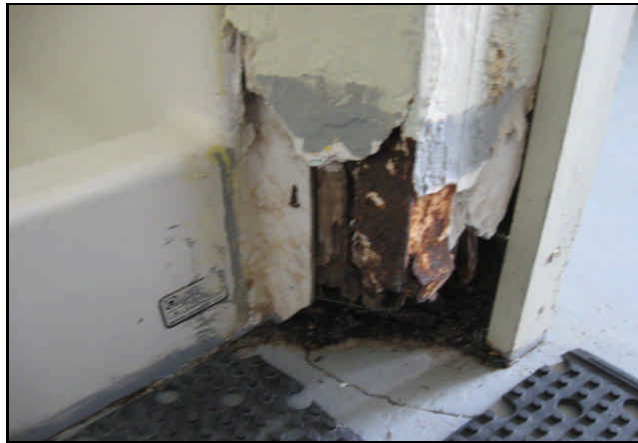
Evaluation : Varying condition - most generally fair, stable. Some water intrusion / damage noted adjacent to one shower (see photo). These areas are utility in nature, but it is likely that some larger repair / replacement projects will be needed, and therefore reserve funding is suggested to supplement the operating budget that covers the annual needs at smaller expense.

Prudent planning suggests setting aside funds for periodic refurbishing which may include items such as: plumbing fixtures, stalls, wall repairs, showers, vanity area, lighting, heating, ventilation, accessories, décor, etc... As routine maintenance, inspect regularly, perform any needed local repairs promptly utilizing general operating funds.

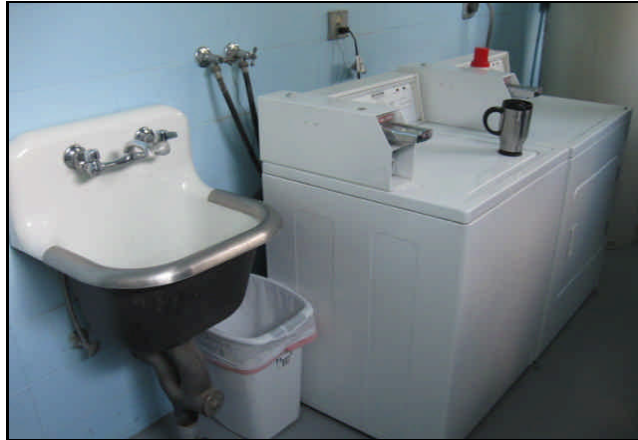
**Comp # : 773 Washer/Dryer - Repair/Replace** Quantity: (2) washers (2) dryers

Evaluation : Washers and dryers assumed to be functioning and in operating order, no problems reported. Too small of an asset to merit reserve funding for repair / replacement. Use maintenance funds as needed.

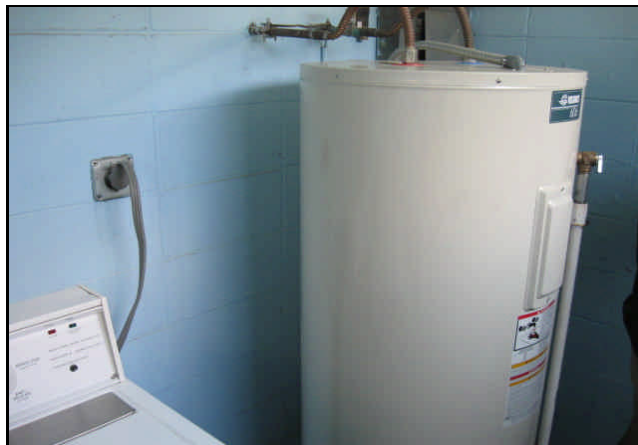
**Comp # : 775 Water Heaters - Replace** Quantity: (3) water heaters

Evaluation : No reported problems or signs of leaks, corrosion, etc.. Best to plan for replacement as needed within the operating / maintenance budget, not as cyclical capital reserve projects.

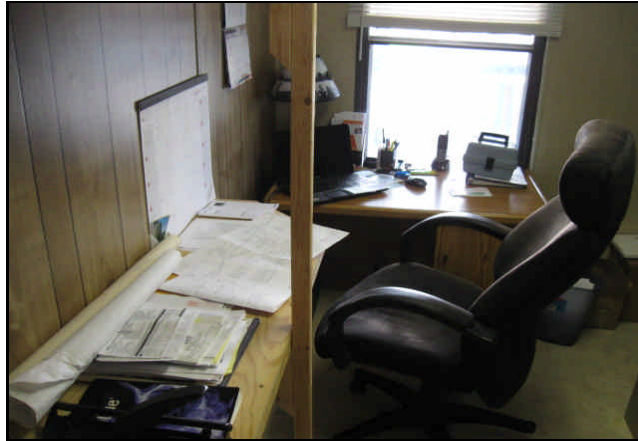
**Comp # : 780      Office Furn & Equip - Replace      Quantity: Desk, chairs, etc...**

Evaluation : Office furniture and equipment appear to be in functional condition. Small office with minimal furniture that should function for extended period if not damaged or abused. Anticipate periodic replacement will be funded as general operating/maintenance expense. No reserve funding suggested

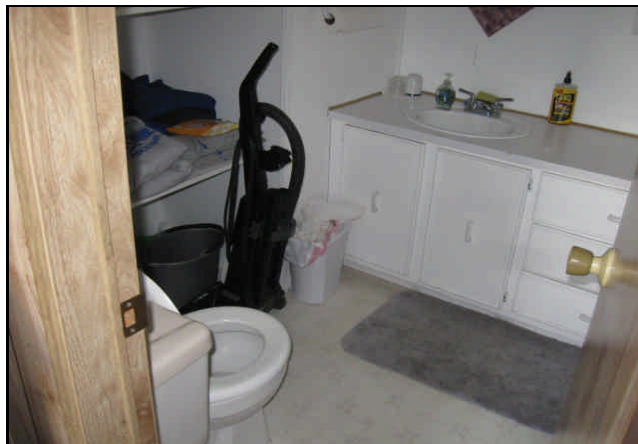
**Comp # : 781      Office Fixtures - Replace      Quantity: HVAC, appliances, etc.**

Evaluation : There is a small bathroom off of the office, in addition to an HVAC unit, flooring and other misc. Fixtures. We expect any repair / replacement of fixtures handled out of operating budget in near term. Eventual replacement of structure is factored in this report: component #550.

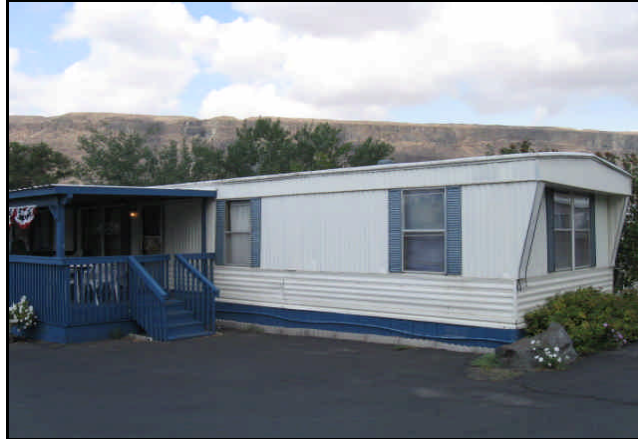
Evaluation : Did not access interior at time of our 2014 site visit. Anticipate periodic need to replace some or all of: flooring, appliances, plumbing & lighting fixtures, etc... This component budgets an allowance for those types of projects. Expect annual expenses such as painting and local minor repair / replace funded as maintenance expense within operating budget.

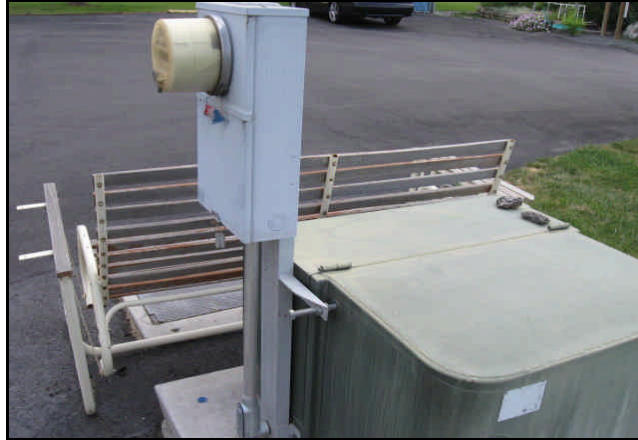
**Comp # : 905      Electrical System - Repair/Replace      Quantity : Electrical distribution**

Funded? : No Useful life not predictable, repair/replace locally as needed out of operating budget

History Phased (III) replacement ~ 2004 - 2006 (~\$710k)
