Rimrock Cove O.A.
Coulee City, WA

Report #: 26309-2
Beginning: January 1, 2024
Expires: December 31, 2024

RESERVE STUDY
Update "With-Site-Visit"

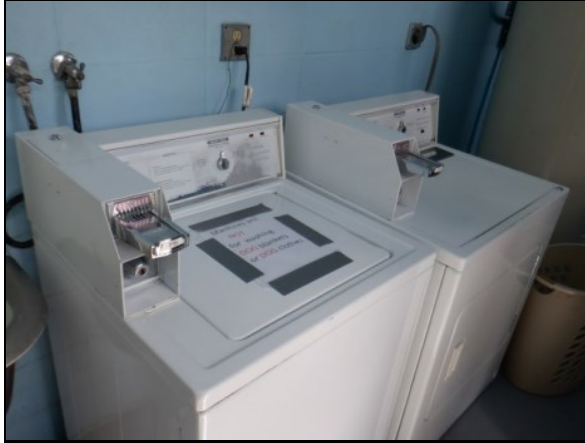
Comp #: 773 Washer/Dryers - Repair/Replace

Comments: Washers and dryers reported to be functioning and in operating condition, no issues or major replacements reported.

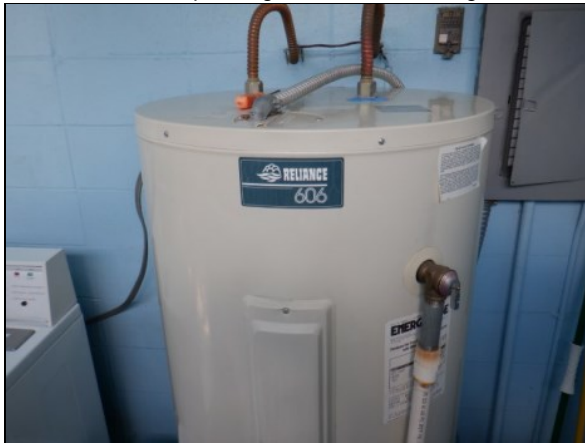
Comp #: 775 Water Heaters - Replace

Comments: No major deficiencies or damage observed or reported with hot water heaters.

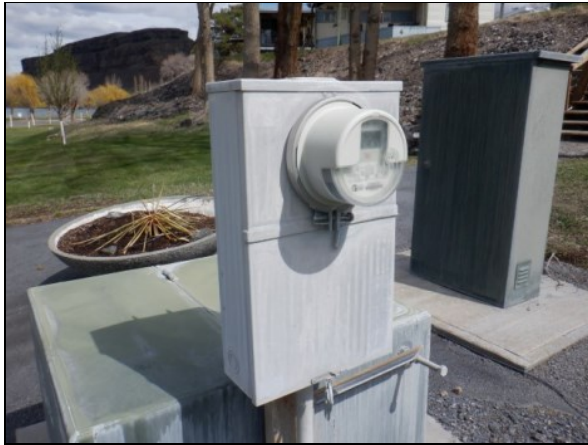
Comp #: 905 Electrical System - Repair/Replace

History: Phased (III) replacement ~ 2004 - 2006 (~\$710k)

Comments: No major issues or repairs noted or anticipated at the time of this study.

It was previously reported in prior studies that distribution system was replaced in the mid 2000's due to failures of the original direct burial cable, and the community's need for increased service capacity, among other issues. The project was overseen by a professional engineer and there are currently no significant problems reported, or predictable expectation for large scale cyclical repair / replacement expenses within the 30-year scope of our report, therefore no reserve funding included.

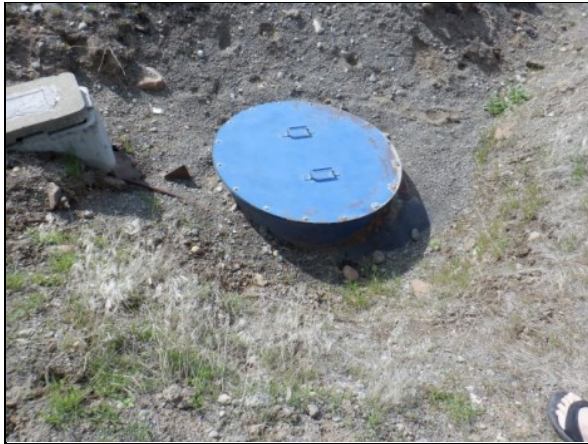
Comp #: 931 Water System Storage - Replace

Comments: Tank is reportedly a steel tank, which typically has a useful life of approximately 60 years. The board of directors reported issues of overflow and various systems issues along with deterioration of the metal tank itself prompting need of replacement. Initial estimated for replacement are factored into component #97 which includes the additional price of additional site prep work. Remaining useful life reset as replacement is anticipated in 2024.
